# Inspection of Compressed Natural Gas Cylinders on School Buses

Acurex Environmental Corporation  
*Mountain View, CA*

Prepared under Subcontract Number YCC-4-14238-01

July 1995

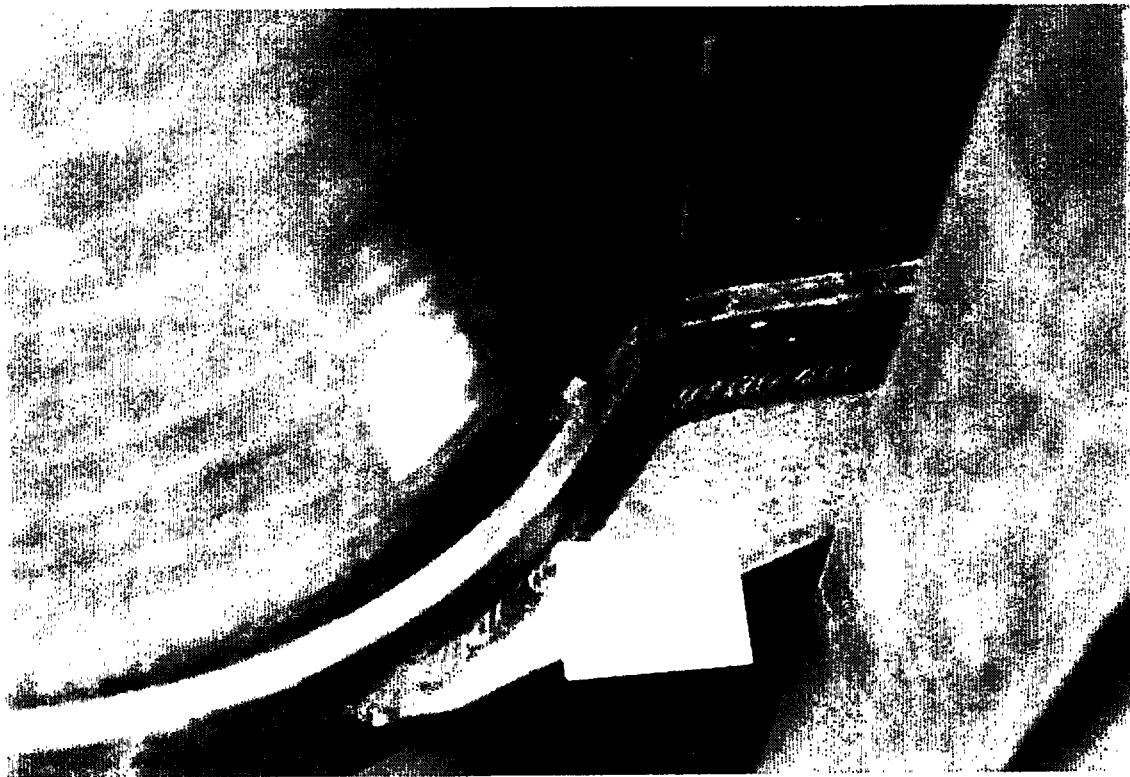
Cylinder B of a second bus was tagged and isolated from the vehicle's remaining three cylinders. Upon inspection, a metal nut was found wedged between the steel support band and the side of the cylinder. The nut was partially embedded into the composite wrap of the cylinder. Figure 4 is a photograph of the embedded nut. The nut appeared to be of the type used for bracket and cylinder installation.

**Figure 4. Nut embedded in cylinder surface of second Site 7 bus**

The site contact and shop supervisor were alerted to the damage to the cylinders. The cylinder shut-off valves were closed, and the cylinders were vented to reduce the pressure. The vehicles were allowed to remain in service, with the damaged cylinders isolated from the rest of the fuel system.

The damage and the hazardous conditions mentioned here were discussed with the site contact, who informed the inspector that the vehicles would be taken to the local distributor so that the damaged cylinders could be tested and repaired/recertified. Additionally, the potential hazards identified would be discussed with the local distributor so that they could be corrected. The cylinders on the two buses were hydrotested and recertified or replaced by a local laboratory.
