Safety Evaluation of the FuelMaker Home Refueling Concept

Final Report

L.R. Waterland
TIAX LLC
Cupertino, California

NREL Technical Monitor: R. Parish

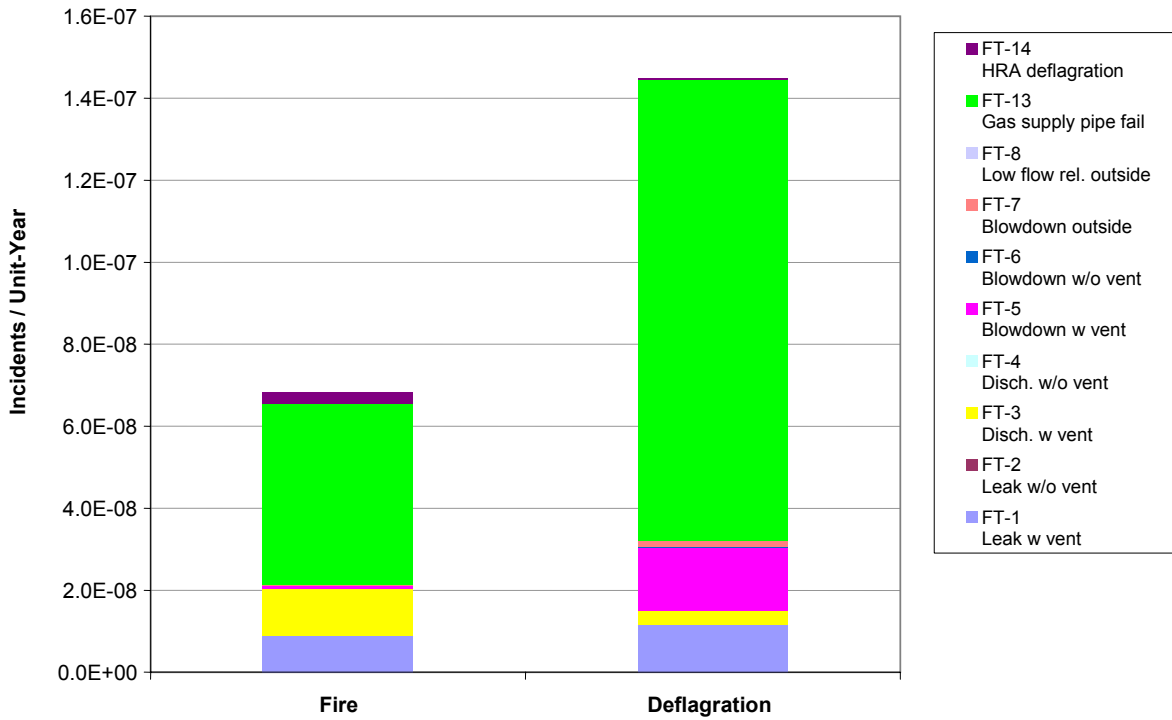
Figure ES-1. Total fire and deflagration frequencies predicted for all HRA incidents except certain misuse scenarios

Eighteen fault trees and event trees characterized the previously discussed incident scenarios, which included various permutations of cooling fan operating (80-scfm ventilation) or not operating (natural infiltration). Some of the misuse scenarios were modeled to recognize that, if an owner was going to misuse the HRA, he or she would be more likely to attempt such misuse within the 1st year after installation, rather than many years later. Although most incident frequencies were characterized in terms of the total number of HRA installations (i.e., cumulative over many years), the misuse frequencies were characterized in terms of the number of HRA installations in the prior year. Figure ES-1 summarizes the predicted fire and deflagration frequencies for all incidents except the noted misuse scenarios; Figure ES-2

summarizes the predicted fire and deflagration frequencies for the misuse scenarios. The frequencies in Figure ES-1 have the units incidents per unit-year, whereas the frequencies in Figure ES-2 have the units incidents per the number of HRAs installed in the prior year.

As illustrated in Figure ES-1, the safety evaluation concluded that the non-misuse failure leading to the highest probability of structure fire and deflagration was gas piping failure resulting from a vehicle striking the HRA. Other significant contributors to the predicted frequency of structure fires and deflagrations are a continuous gas leak and a full-flow gas discharge, both with the HRA cooling air fan operating normally. A vehicle tank blowdown into the garage with the cooling air fan in operation contributes significantly to the predicted frequency of deflagrations.

An HRA deflagration due to air entering the appliance contributes to the predicted frequency of structure fires. A deflagration associated with HRA use is predicted to be roughly twice as frequent as a structure fire. The total predicted frequency of a deflagration from all non-misuse causes considered in the analysis corresponds to one predicted deflagration per year after a total of about 7,000,000 HRAs have been installed. The corresponding result for structure fires is that one fire per year is predicted after a total of 14,600,000 HRAs have been installed.

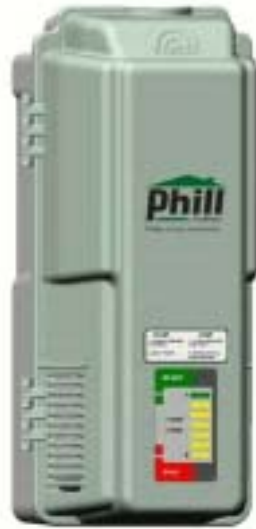
Figure 2-1. The FuelMaker Corporation Home Refueling Appliance is also referred to as "Phill"

The FuelMaker HRA is a fully integrated self-contained device that is designed to be mounted on the inside wall of a residential garage. It receives standard residential natural gas and electric service, and it enables time-fill (e.g., overnight) refueling of a CNG vehicle parked in the garage. The HRA contains a dryer, a compressor, controls, and safety systems (including a leak detector within a ventilated housing). Compressed gas is delivered to the vehicle through a flexible high-pressure hose (which retracts into the housing) and a NGV 1 Type 3 nozzle. The HRA provides a nominal gas flow rate approximately 0.67 scfm and a maximum outlet pressure of approximately 3,600 psi.

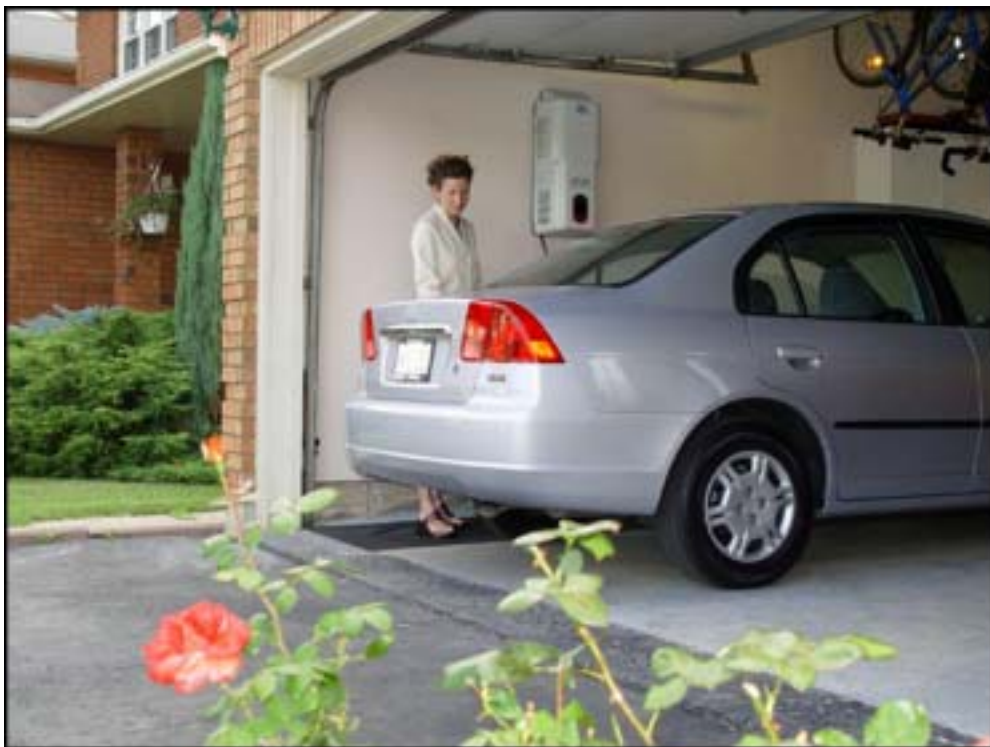
Figure 2-2. The FuelMaker Home Refueling Appliance is designed to enable CNG vehicles to be refueled inside residential garages

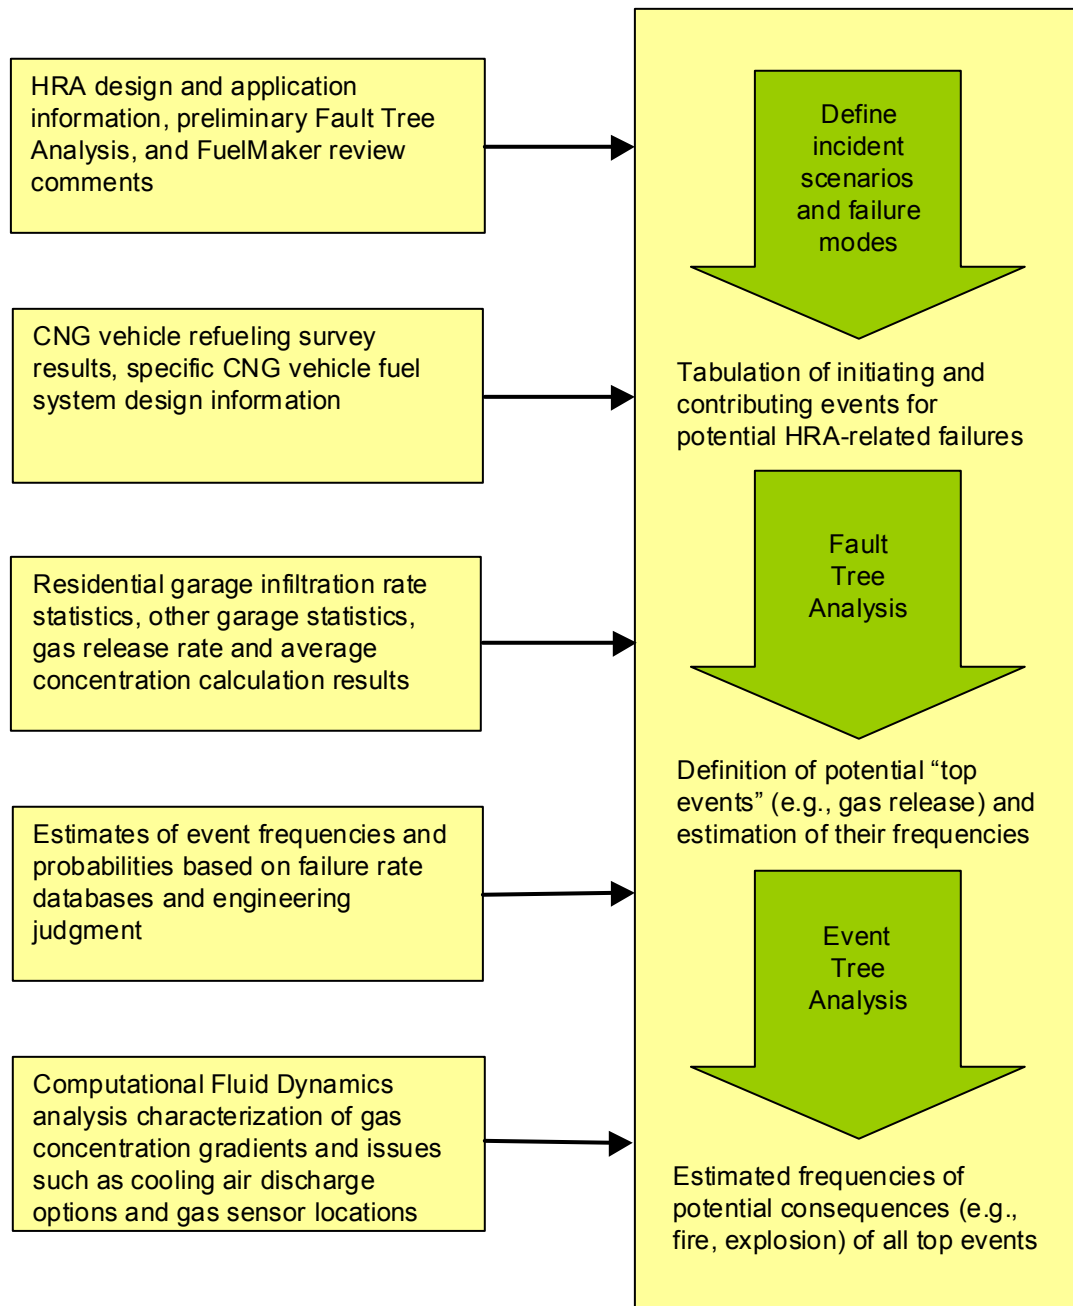
Figure 2-3. Summary of the overall HRA safety evaluation process

The overall analysis process employed in this project is illustrated in Figure 2-3. This section overviews this process, and details of the various methodologies employed are explained in subsequent sections. In Figure 2-3 the basic process steps are indicated by the three thick arrows, the outputs from each step are shown below the thick arrows, and the various supporting analyses are listed in the boxes on the left.

As outlined in Section 2.2 and illustrated in Figure 2-3, the HRA safety evaluation process used in this project employed the following sequential steps:

As applied in this study, the FTA predicted the frequencies of top events (such as gas releases) but not the consequences (e.g., potential fires or deflagrations). As explained in Section 2.2 and illustrated in Figure 2-3, event tree analysis (ETA) was applied to each top event to predict the resulting consequence frequencies.

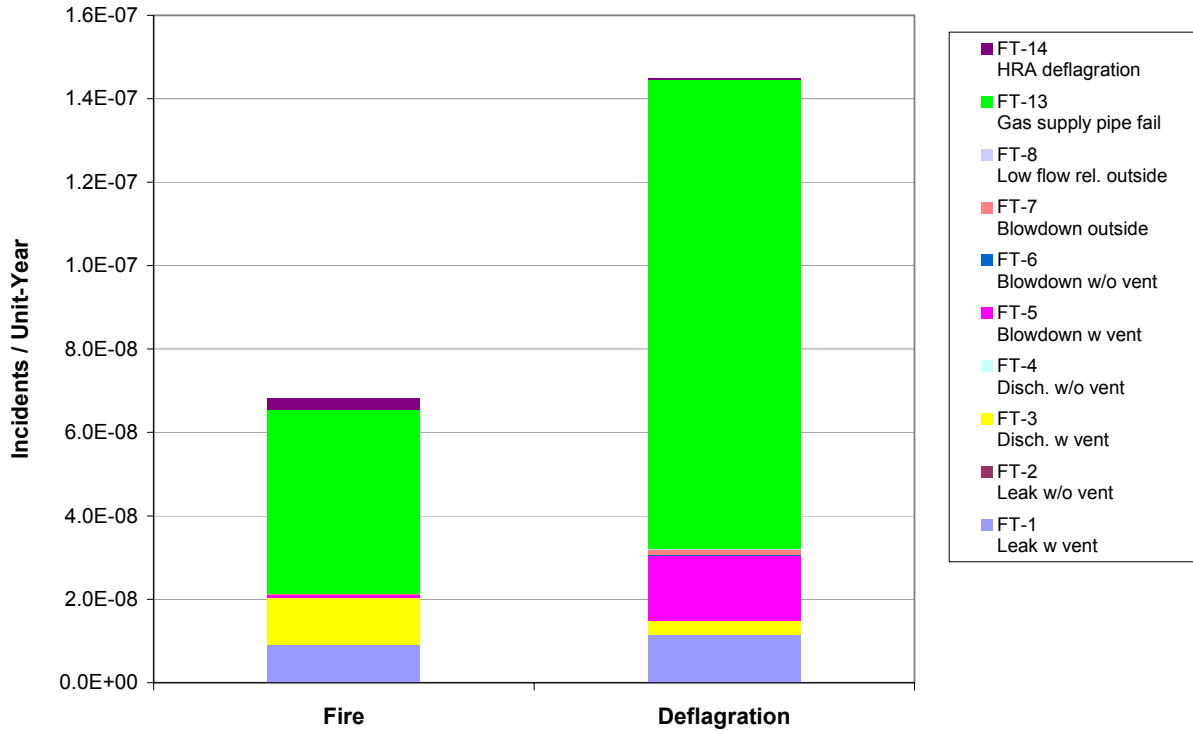
Figure 3-5. Consequence frequencies predicted by the FTA and ETA that have the units of incidents/unit-year

Figures 3-5 and 3-6 summarize the contributions to predicted structure fire and deflagration frequencies for events that are characterized by the units of incidents / unit-year and incidents / units installed in prior year, respectively.

Figure 3-5 shows that, for the non-misuse failures, a deflagration associated with HRA use is predicted to be roughly twice as frequent as a structure fire. The most likely cause of either structure fires or deflagrations is predicted to be a gas release resulting from a gas supply pipe failure due to the HRA being struck by a vehicle and the supply pipe breakaway fails. Other significant contributors to the predicted frequency of both structure fires and deflagrations are a continuous gas leak and a full flow gas discharge, both with the HRA cooling air fan operating normally (i.e., with ventilation). A vehicle tank blowdown into the garage with the cooling air fan in operation provides a significant contribution to the predicted frequency of deflagrations; an HRA deflagration due to air ingress provides some contribution to the predicted frequency of structure fires. The total predicted frequency of a deflagration from all non-misuse causes considered in the analysis corresponds to one predicted deflagration per year after a total of about 7,000,000 HRAs have been installed. The corresponding result for structure fires is that one fire per year would be predicted after a total of 14,600,000 HRAs have been installed.

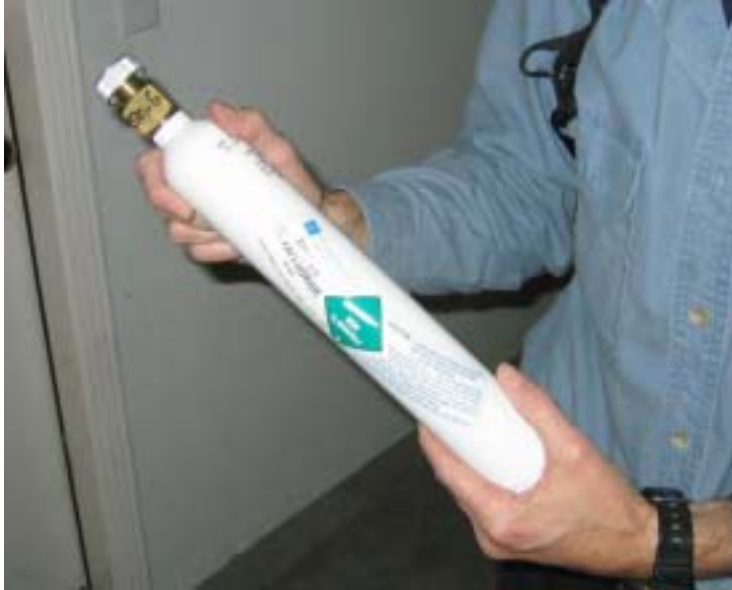
Figure 5-2. The SF₆ tracer gas is released into the garage to provide a starting concentration of 5 to 10 ppm

The tracer gas method developed under various NREL building energy programs uses sulfur hexafluoride (SF_6) as the tracer gas, because it is inert, nontoxic, nonreactive, and easily detected. SF_6 contained in small pressure vessels (Figure 5-2) is released to provide an initial concentration of about 5 to 10 ppm (this initial concentration is not critical to the measurement accuracy). The mixing of SF_6 in the garage space is aided by a very small fan that has a negligible effect on the garage ACH. Sampling lines are placed in the garage interior, and the lines draw the sample out of the space (typically under a door) and to the measurement instrumentation. The instrumentation used for these measurements was an NREL Bruel kjaer photo-acoustic spectrometer (Figure 5-3). A wind-speed anemometer is located as high as practical near the structure (e.g., on the roof of the house associated with one of the garages measured, as shown in Figure 5-4). Thermocouples are used to measure the temperature inside of the structure space as well as the exterior temperature. The gas concentration, wind speed, and temperatures are recorded as functions of time using a data acquisition system.

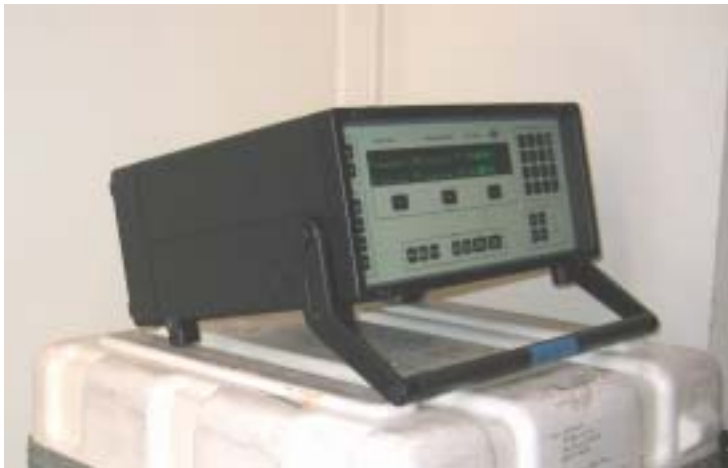
Figure 5-3. The NREL Bruel kjaer photo-acoustic spectrometer is used to measure the SF₆ concentration

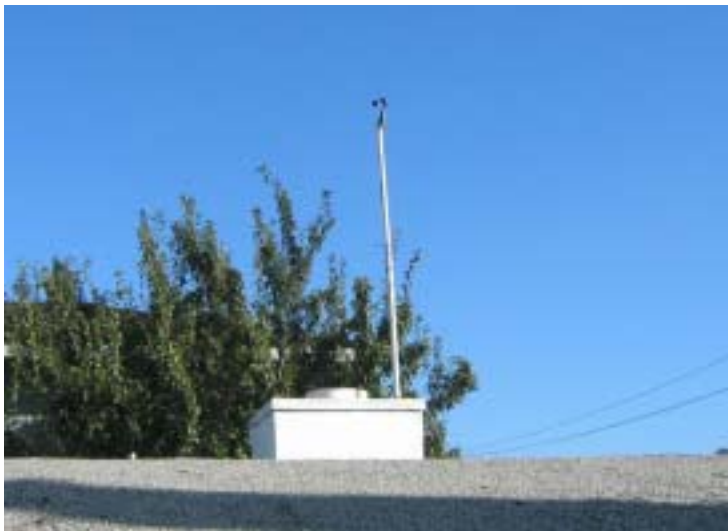
Figure 5-4. An anemometer is usually installed high on the building roof to measure wind speed

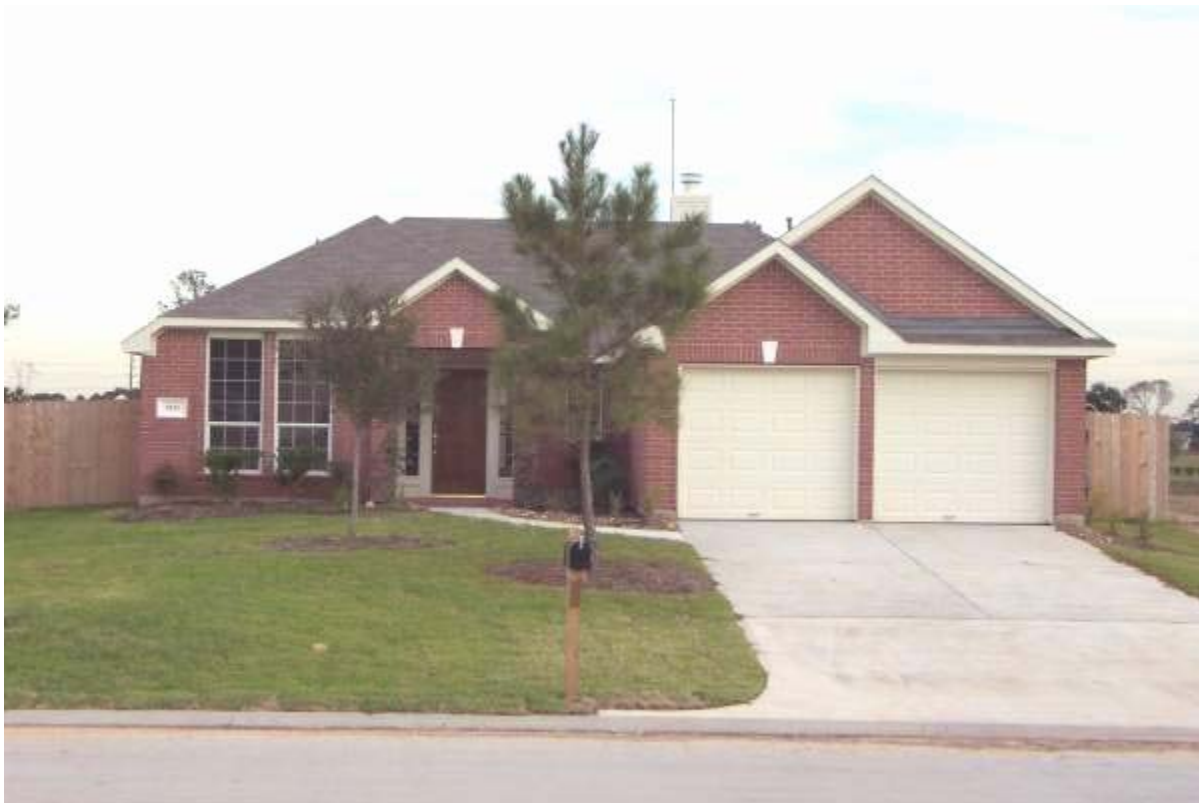
Figure 5-5. The first garage infiltration measurement was made at this Spring, Texas, house

The locations and characteristics of the three garages for which infiltration measurements were made are listed in Table 5-1. The house in Spring, Texas (near Houston) is used by NREL for various building energy studies. It has an attached two-car garage. The infiltration test equipment and personnel were already in this area, so this garage was selected as the first one to be tested. Figure 5-5 is a photograph of the Spring, Texas, house, and Figure 5-6 shows the inside of the garage.

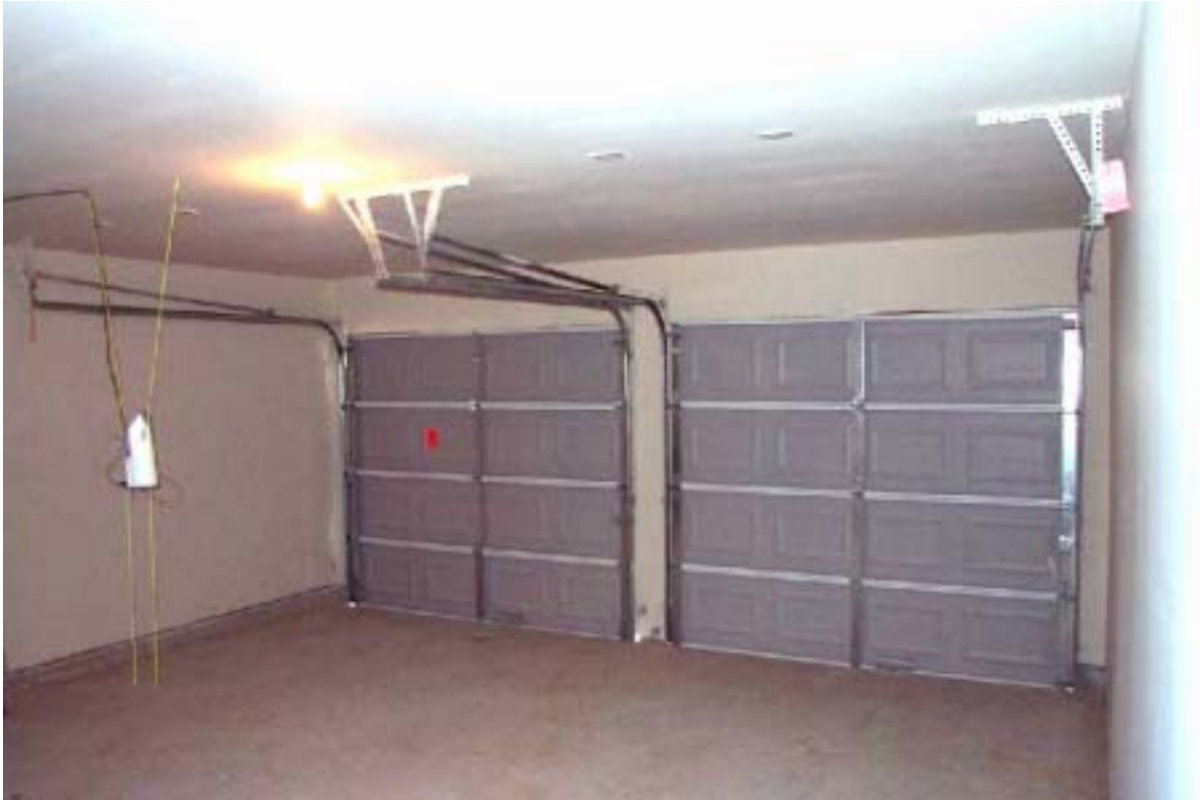
Figure 5-6. The Spring, Texas, house is a new home with an attached two-car garage

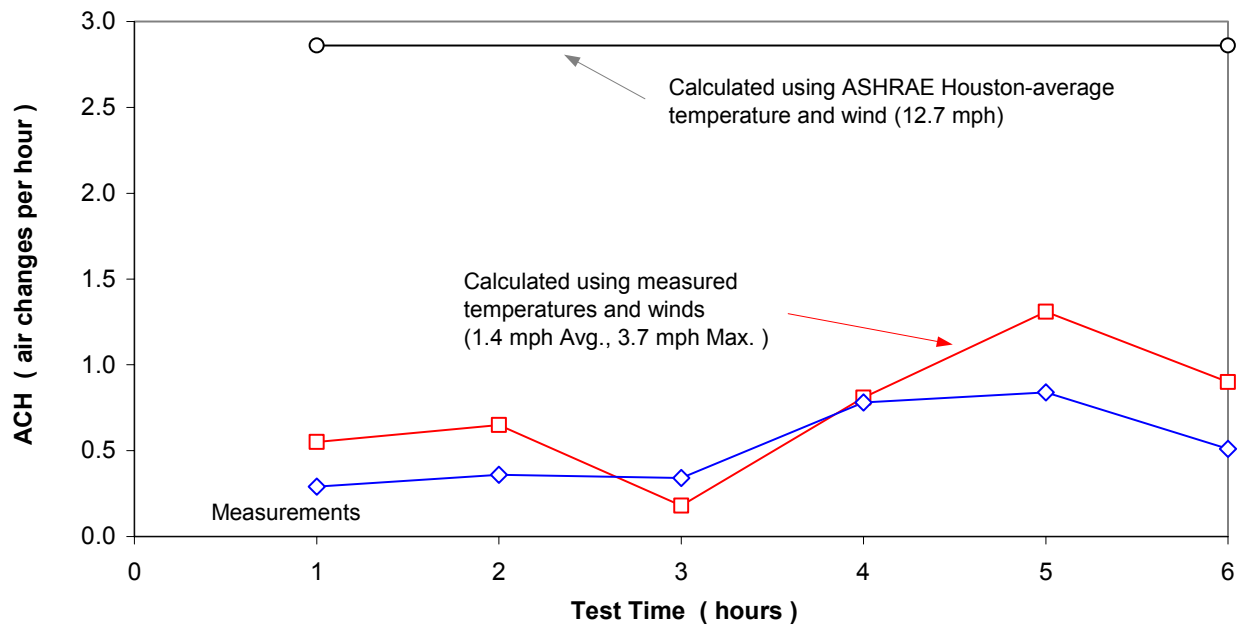
Figure 5-7. Spring, Texas, garage ACH measurement compared with predictions using measured wind speed and Houston-average wind speed

On the day when the Spring, Texas, garage infiltration measurements were made, the wind speed was exceptionally low. The measured wind speed varied from zero to 3.7 mph, and the average was about 1.4 mph. For comparison, the previously cited ASHRAE database indicates that Houston has an average prevailing wind speed of 12.7 mph. Figure 5-7 shows the measured

ACH as a function of time over a 6-hour period when the wind speed was at least high enough to produce meaningful data. This is compared with the ACH calculated using the methodology explained in Appendix D, inputs from the completed survey form for the Spring, Texas, garage, and the actual wind speed measured with the anemometer. Figure 5-7 also shows the calculated ACH based on the Houston-average wind speed of 12.7 mph.

Figure 5-7 indicates that the agreement between the measurement and the calculation is surprisingly good considering the exceptionally low wind speed and the very approximate nature of the calculation methodology. The measurement was somewhat less than 0.5 air changes per hour during the first three hours and somewhat more (but less than 1 air change per hour) during the subsequent three hours. This relatively low ACH is strictly due to the very low wind speed. The calculation using the Houston-average wind speed is about 2.8 air changes per hour. This indicates that this is a relatively “leaky” garage, and this is due to the relatively large (approximately 3/8 inch) gaps around the garage “car” doors.

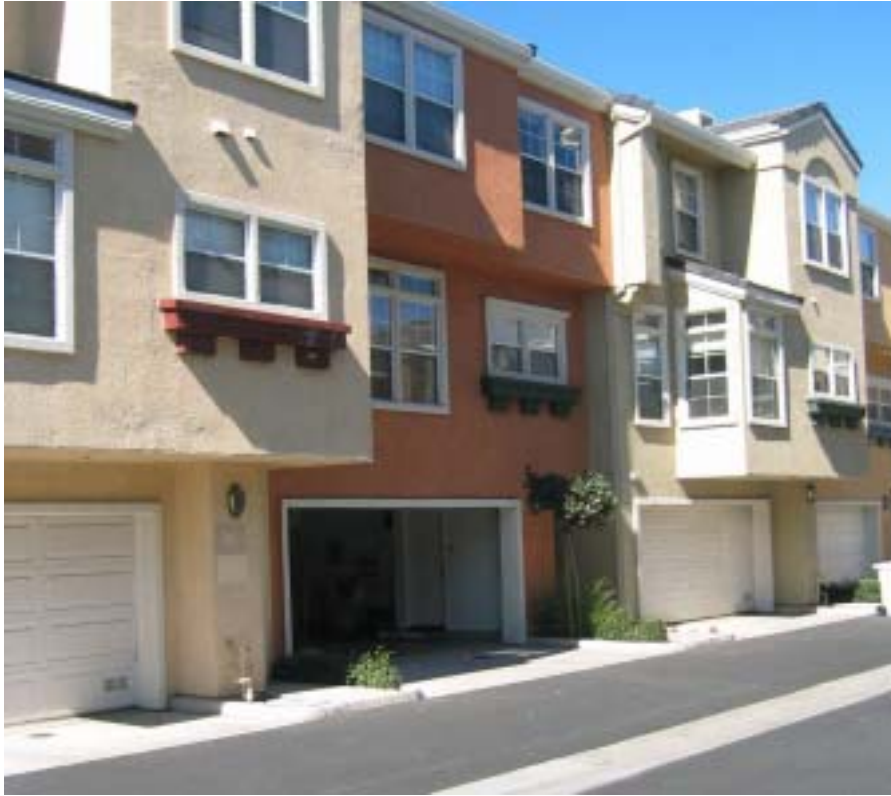
Figure 5-8. The ACH of this condominium garage in Fremont, California, was measured

Two measurements were then made for garages in the San Francisco Bay Area. Figure 5-8 shows the garage on the ground-level floor of the three-story condominium in Fremont, California. The basic characteristics of this garage and condominium are listed in Table 5-1. A noteworthy characteristic of this garage is the substantial wind shielding because of the “canyon-like” environment associated with the configuration of this condominium complex (Figure 5-9). It was originally anticipated that this would be a relatively low-leakage garage, but it was subsequently observed that, while most of the garage “car” door fit tightly, there was a substantial air gap along the top of the door.

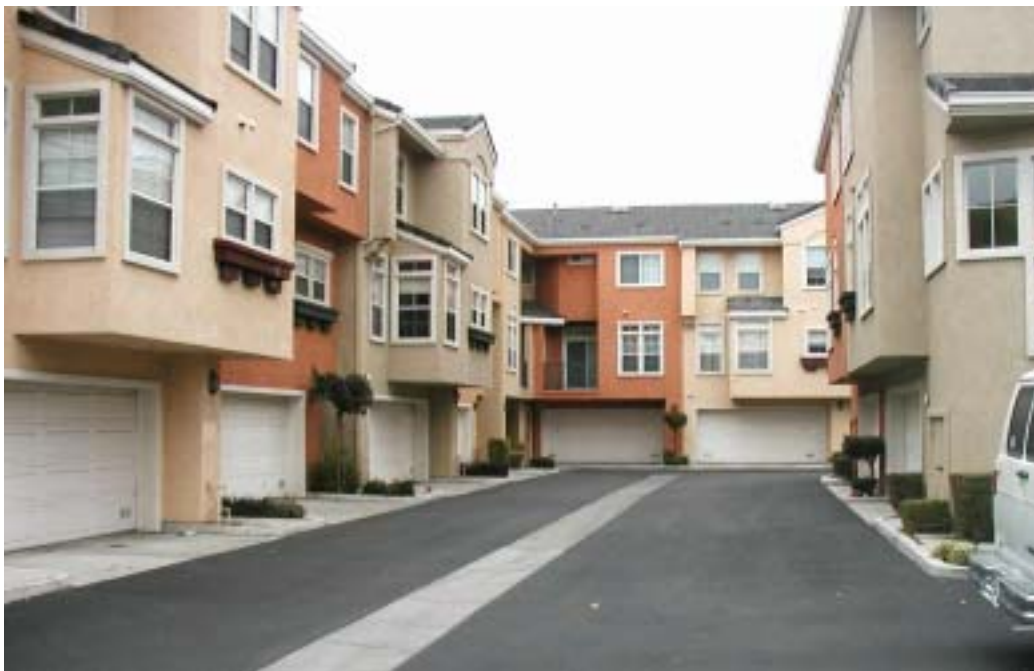
Figure 5-9. The Fremont, California, garage had substantial wind-shielding due to the “canyon-like” configuration of the condominium complex

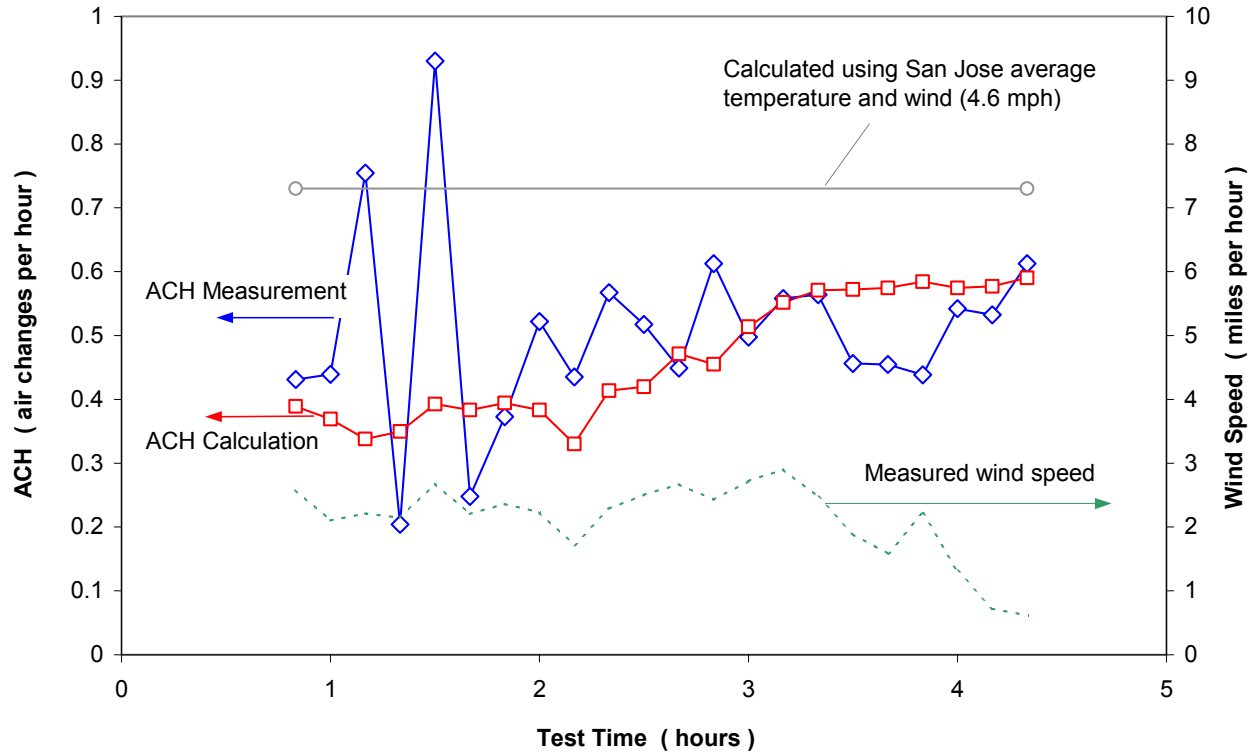
Figure 5-10. Fremont, California, garage ACH and wind speed measurements compared with ACH predictions using measured wind speed and San Jose average wind speed

Figure 5-10 shows the measured ACH and wind speed for the Fremont, California, garage over a four-hour period. This is compared with the calculated ACH based on the measured wind speed and the average prevailing wind speed (4.6 mph) published by ASHRAE for San Jose, California. Figure 5-10 shows that the measured wind speed was roughly half of the San Jose average until late in the test, when it decreased substantially. The figure also indicates that there were substantial fluctuations in the measured ACH (which is actually also a calculation, based on tracer gas concentration measurement differences, as previously discussed) during the first hour of the test. However, the overall conclusion from Figure 5-10 is that the calculated and measured ACH are in quite good agreement.

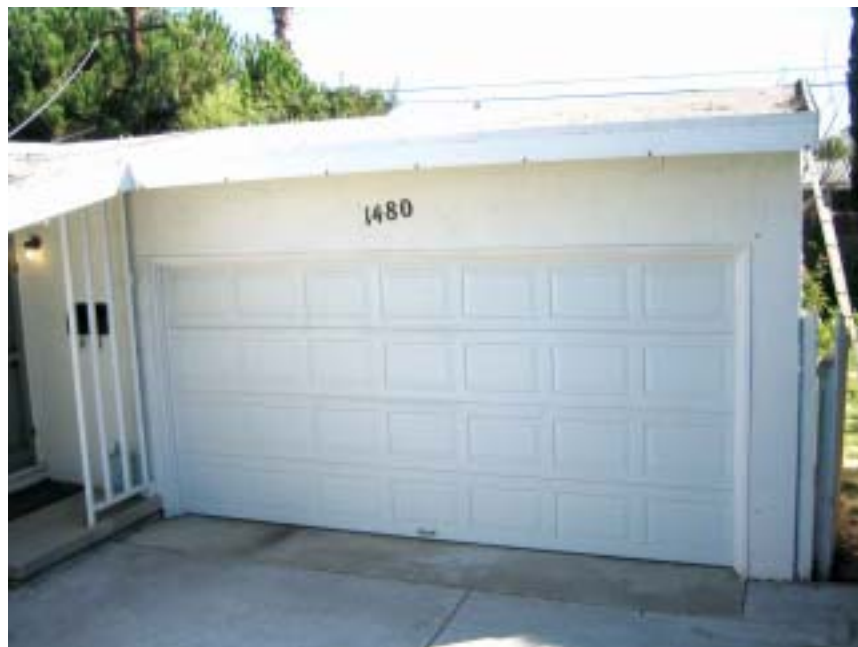
Figure 5-11. The ACH of this attached two-car garage in San Jose, California, was measured

For the third garage ACH measurement, it was desired to test a relatively low-leakage garage in order to check the calculation methodology in the low-ACH regime. We identified a house in San Jose with an attached two-car garage (Table 5-1 and Figure 5-11) that had recently had a new garage door installed. The new upward-retracting hinged-panel garage door was sealed with vinyl flaps (Figure 5-12), which appeared to ensure low leakage (i.e., a relatively low contribution to the “L” term in the equation discussed in Section 5.3). This particular garage also had a small vent opening near the ground on one side, which we sealed during most of the measurement period.

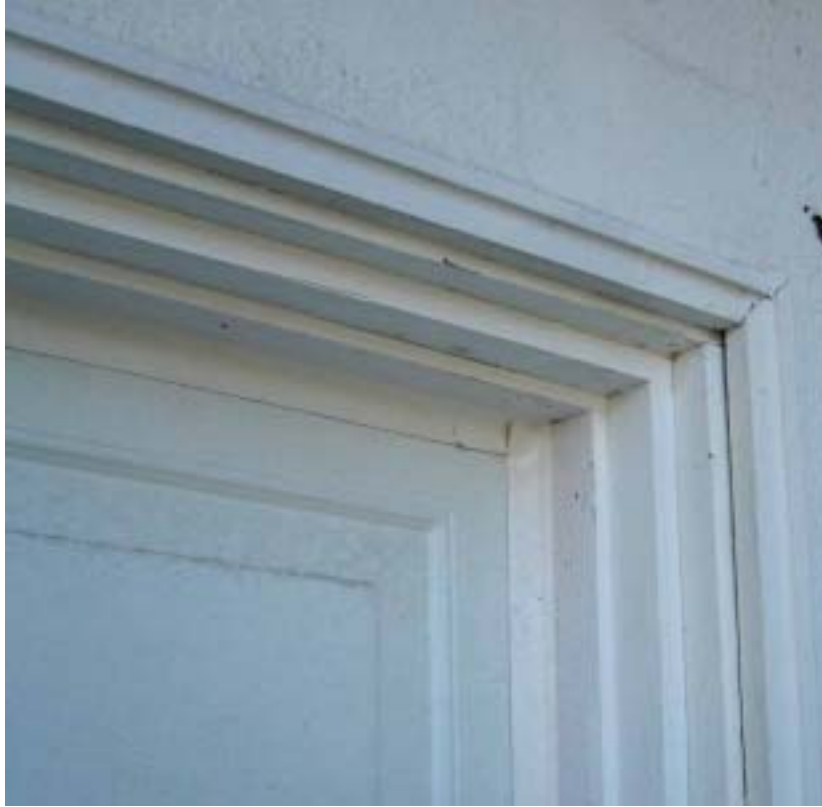
Figure 5-12. The San Jose garage was selected because the door was sealed by vinyl flaps, which were anticipated to provide a low ACH

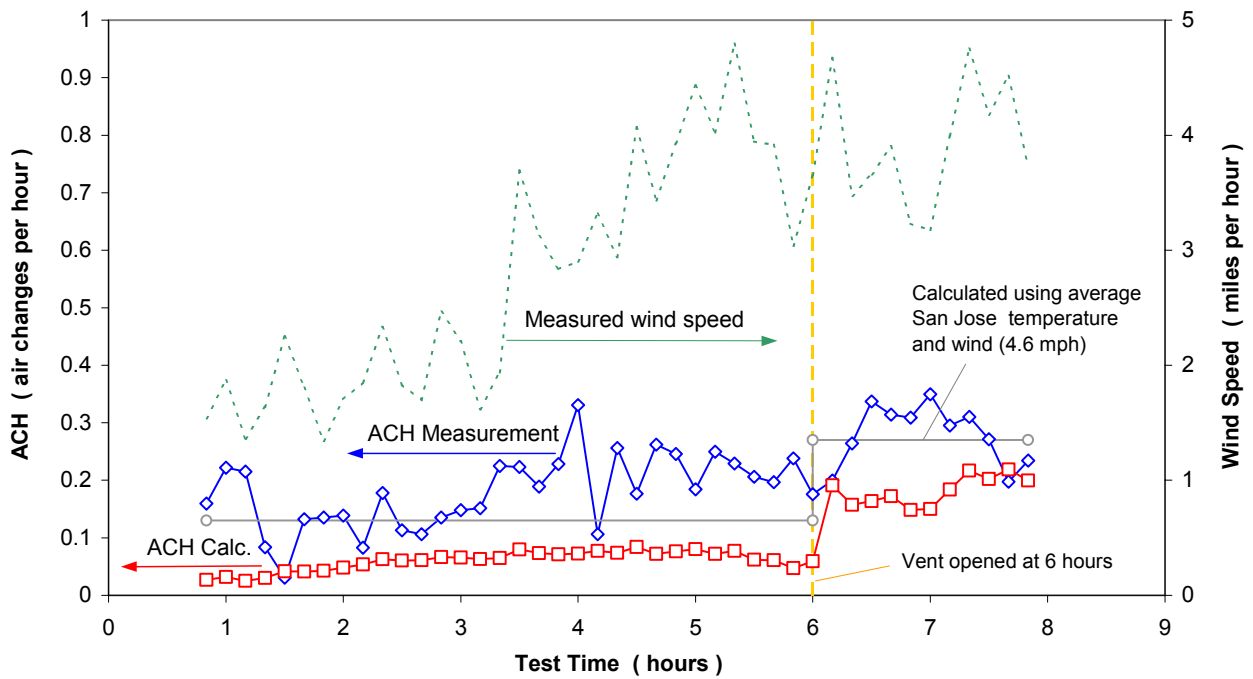
Figure 5-13. San Jose, California, garage ACH and wind speed measurements compared with ACH predictions using measured wind speed and San Jose average wind speed

The ACH and wind speed measured over an eight-hour period for the San Jose garage are shown in Figure 5-13. This figure also shows the ACH prediction based on the measured wind speed and the San Jose average prevailing wind speed of 4.6 mph. Note that the measured wind speed increased during the first five hours of the test and then fluctuated near an average of

approximately 4 mph (i.e., near the average published by ASHRAE). Because this test was over a relatively long time period and measurements during the first few hours appeared to be consistent, we decided to remove the seal from the vent (which was approximately 4 inch x 5 inch) at six hours in order to obtain data for this configuration.

Figure 5-13 shows that, with the vent sealed, the calculated ACH significantly underpredicts the measurement. When the vent was unsealed, the measured ACH increases as expected, but the predicted ACH increases by a higher percentage. The results are that the calculated ACH more nearly predicts the measurements after the vent is unsealed. We speculate that the reason for the ACH underprediction may be associated with air leakage paths that we did not see and account for when evaluating the “L” term in the equation discussed in Section 5.3. This garage had obviously been modified a number of times, and there were areas where openings in the interior sheet rock may have been in communication with openings in the exterior siding, for example.

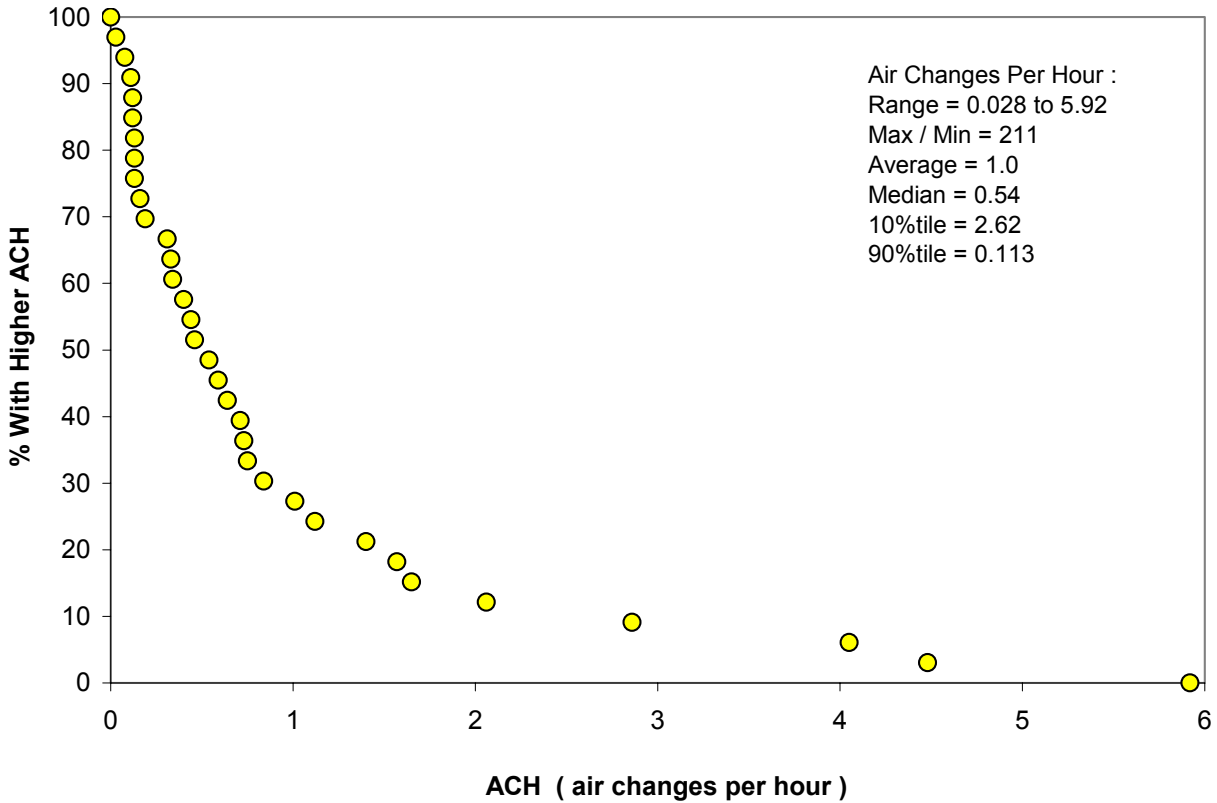
Figure 5-14. Population distribution of calculated ACH values for the 33 residential garages surveyed

Figure 5-14 shows the distribution of ACH values for the 33 garages for which survey forms were completed (the locations of these garages were indicated in Figure 5-1). These ACH values were calculated using the methodology discussed in Section 5.3 and Appendix D, i.e., they are based on the information in the survey forms and the average prevailing winds and temperature ranges at the nearest city listed in the ASHRAE weather database. The ACH values are graphed as a population distribution in Figure 5-14, i.e., the vertical scale indicates the percentage of garages with ACH values higher than the ACH value on the horizontal scale.

The calculated ACH values range from a low of 0.028 (for a very large garage in Mesa, Arizona, with weather stripping around the door) to a high of 5.92 (for a small garage in Brampton, Ontario, with a very loose-fitting one-piece swing-up door). As indicated in Figure 5-14, the average ACH was 1.0 and the median ACH was 0.54. The tenth and ninetieth percentile ACH values are 2.62 and 0.113, respectively (based on linear interpolation between data points). Correlation of the computed ACH values with the garage characteristics from the survey forms indicates that, in general (with some exceptions), the garages fall into the three ACH ranges summarized in Table 5-2.

The residential garage ACH statistics summarized in Figure 5-14 are needed to estimate various event tree probabilities, as discussed in Section 3.4. Other residential garage statistics, which are potentially pertinent to the HRA event tree analyses, were also abstracted from the survey forms.

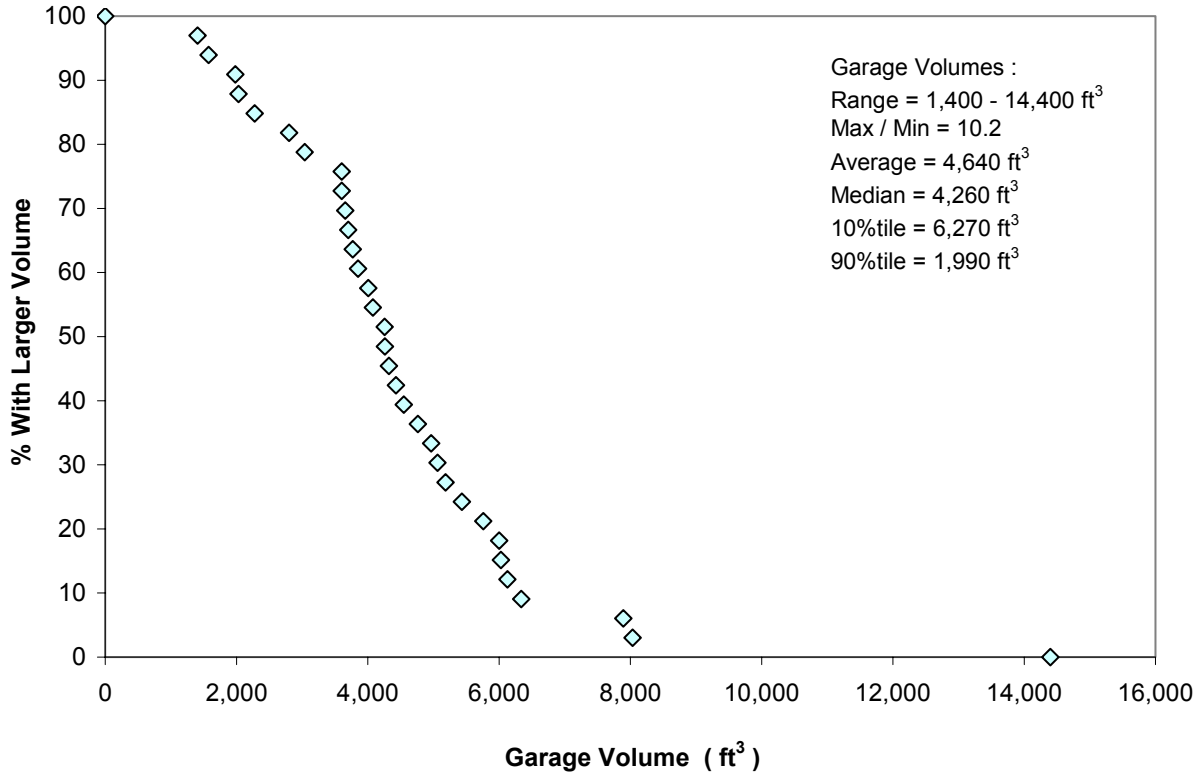
Figure 5-15. Population distribution of interior volumes of the 33 surveyed residential garages

For example, Figure 5-15 shows the population distribution of the interior volume of the 33 surveyed garages. Note that the interior volume does not include any subtraction for objects in the garage (e.g., vehicles, appliances, stored items) that might decrease the effective volume. As indicated in Figure 5-15, the average and median garage volume are 4,640 ft³ and 4,260 ft³, respectively. The tenth and ninetieth percentile volumes are 6,270 ft³ and 1,990 ft³, respectively. The 14,400 ft³ garage data point in Figure 5-15 is the previously mentioned unusually large garage in Mesa, Arizona.

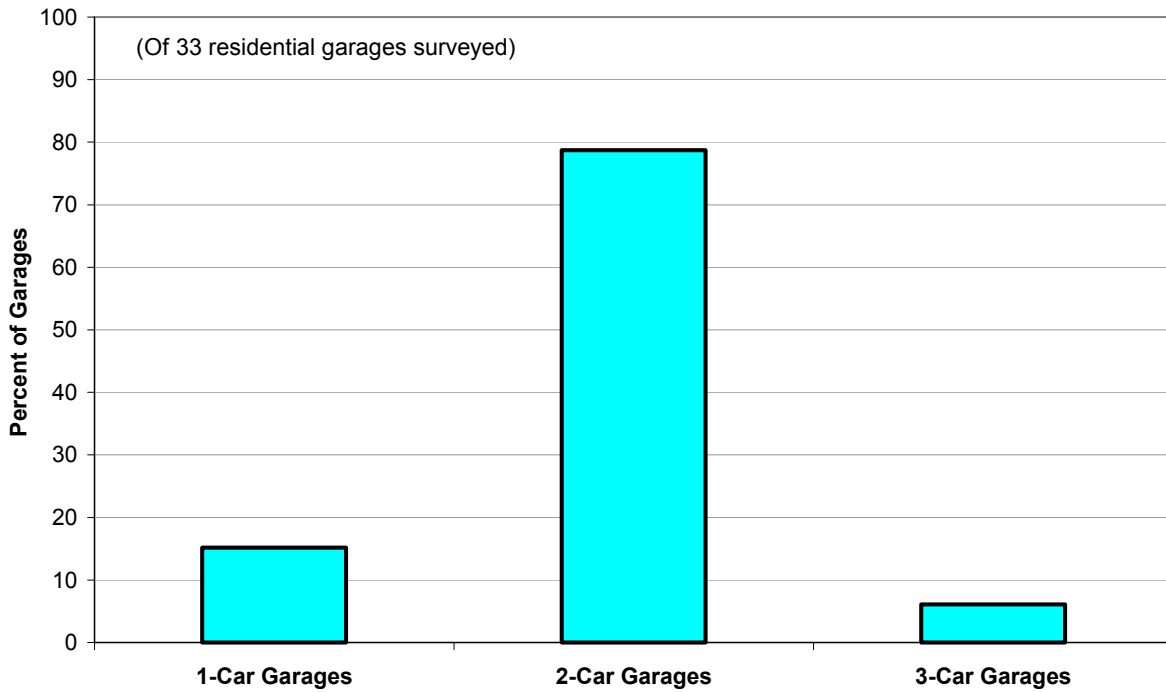
Figure 5-16. The great majority of the garages surveyed were 2-car garages

Figure 5-16 and 5-17 are bar charts that summarize some other potentially pertinent residential garage statistics. Figure 5-16 shows that, as expected, the majority (79%) of the surveyed

garages are two-car garages. Most of the garages have potential ignition sources, e.g., overhead electric garage door openers (82%) or natural gas appliances (30%). Approximately 88% of the garages have wood framing and 24% are all-wood construction. Leaked gas accumulation around the electric garage door opener may be affected by the fact that 70% of the garages have flat ceilings, and the fact that approximately 82% of the garages are attached to houses may affect the consequences of a worst-case deflagration scenario.

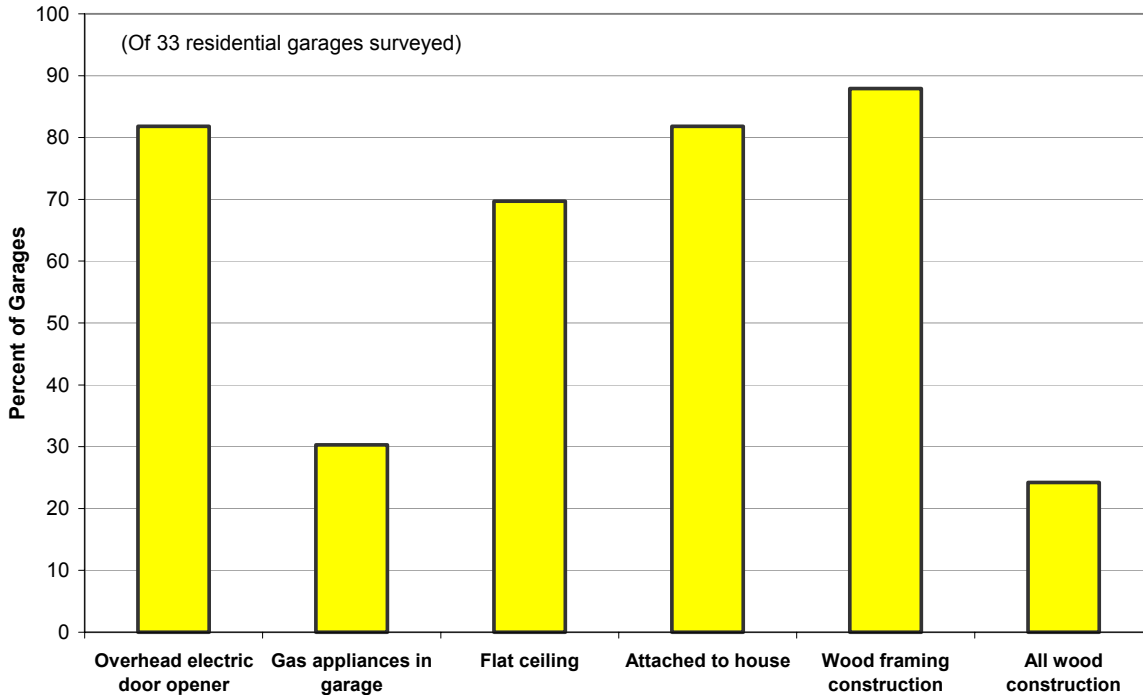
Figure 5-17. The garage survey results yielded other approximate statistics that may be pertinent to HRA applications

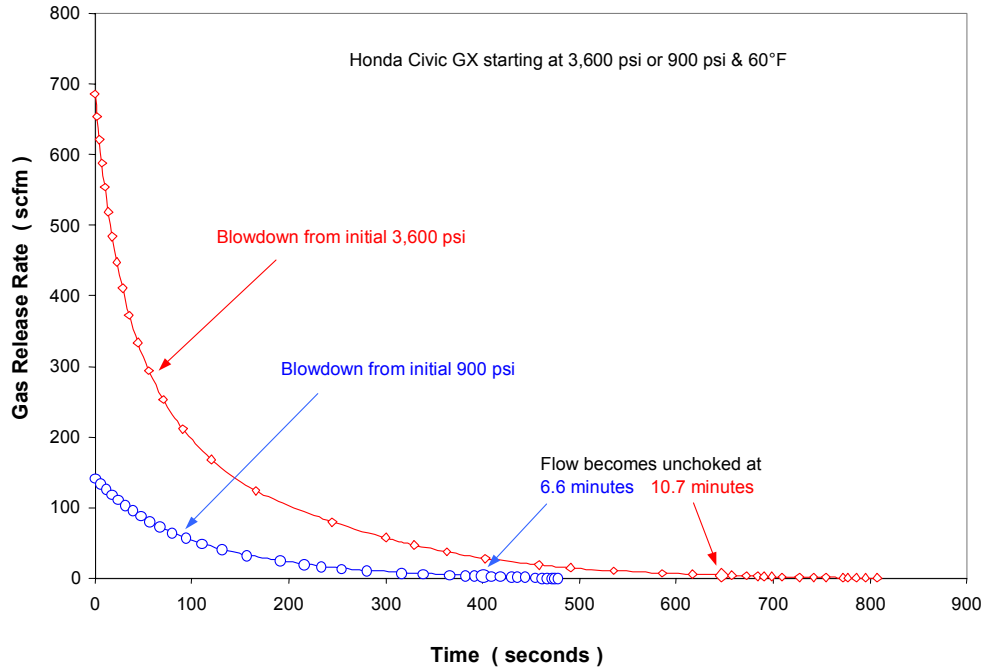
Figure 6-2. Calculated CNG vehicle fuel tank blowdown gas release for conditions listed in Table 6-1

Figure 6-2 shows the time-dependent gas release rates for the two CNG vehicle fuel tank blowdown situations summarized in Table 6-1, i.e., a Honda Civic GX starting at 900 psi and 3,600 psi. The points where the flow becomes unchoked are indicated in Figure 6-2. In each case, more than 99% of the gas has been exhausted by the time the flow becomes unchoked, which justifies the approximate way the fuel system flow path friction characteristics were estimated. Figure 6-3 shows the computed blowdown gas release rates plotted in log-log coordinates so that they can be compared to the much smaller HRA release rate of 0.67 scfm and assumed leak rate of 0.22 scfm. The logarithmic time scale enables the blowdown event, which lasts for less than 15 minutes, to be compared to the typical refueling time of 8 hours (which is a representative time period during which the HRA might leak).

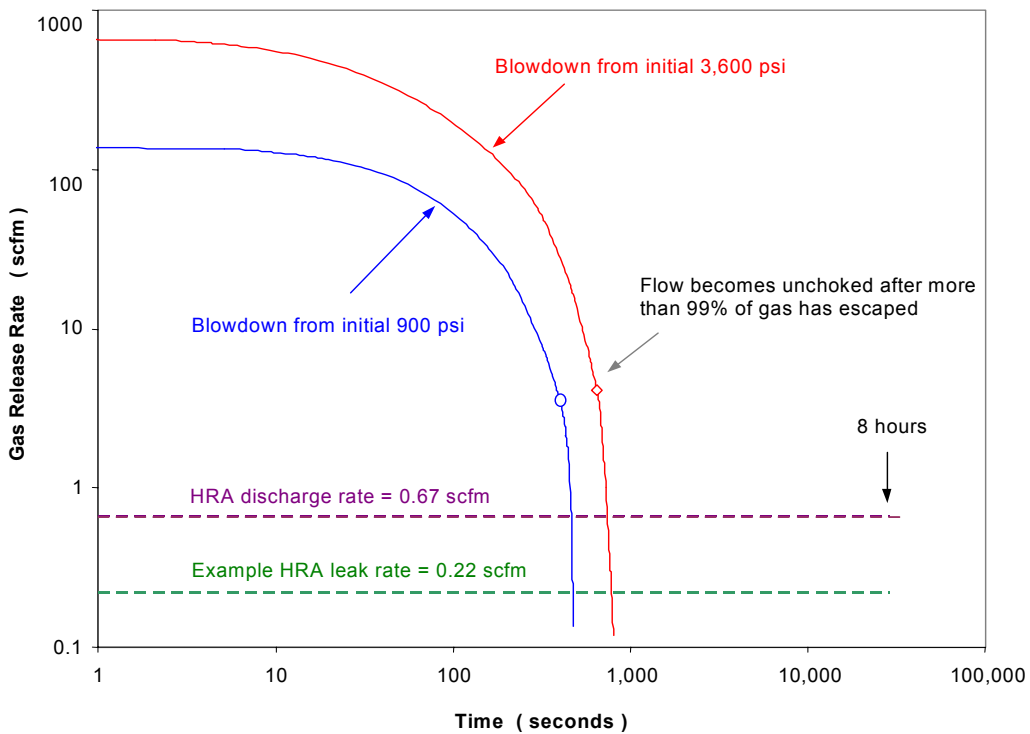
Figure 6-3. Comparison of calculated vehicle blowdown and assumed HRA discharge and leak rates (note logarithmic scales)
