Safety Evaluation of the FuelMaker Home Refueling Concept

Final Report

L.R. Waterland
TIAX LLC
Cupertino, California

NREL Technical Monitor: R. Parish

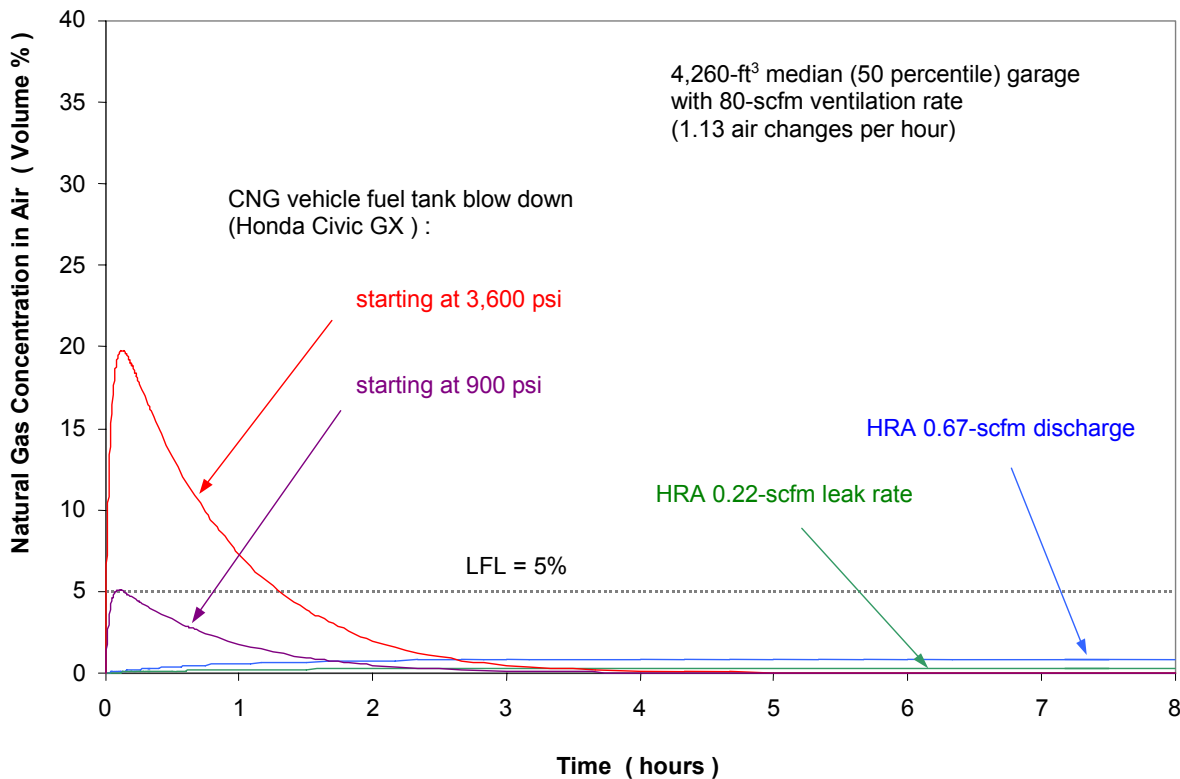
Figure 6-4. Average gas concentration histories for the considered blowdown, discharge, and leak scenarios in a median-volume garage with 80-scfm ventilation

Note that each of these causes represents a different number of air changes per hour, because ACH depends on the garage volume as well as the air flow rate. The median, tenth percentile, and ninetieth percentile garage volumes were discussed in Section 5.5. Figure 6-4 shows the computed average natural gas concentration histories in a median-volume garage (4,260 ft³) with

80 scfm ventilation for the considered blowdown, discharge, and leak situations. In this case, a blowdown release from a CNG vehicle full fuel tank would cause the average gas concentration to abruptly exceed the LFL (by as much as a factor of four) and remain above the LFL for more than one hour. A blowdown release from a CNG vehicle fuel tank filled to 900 psi would produce an average gas concentration that peaks at approximately LFL and decays to less than a third of the LFL in one hour. For these conditions, the maximum average gas concentrations produced by a 0.22-scfm leak or a 0.67-scfm discharge are approximately 0.3% and 0.8%, respectively, which are substantially less than the 5% LFL. Graphs of average gas concentrations for all three of the previously listed 80-scfm ventilation and garage volume combinations are contained in Appendix E.

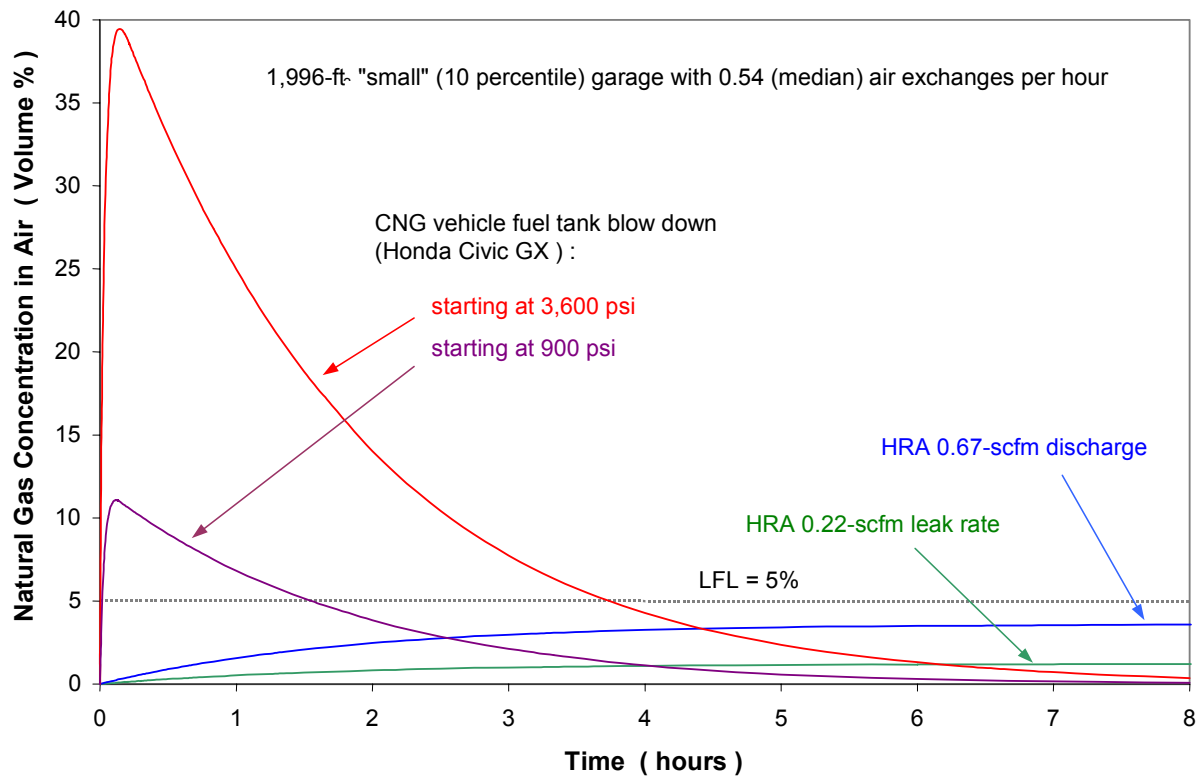
Figure 6-5. Average gas concentration histories for the considered blowdown, discharge, and leak scenarios in a tenth percentile (“small”) garage with a median ACH

The median, tenth percentile, and ninetieth percentile garage volume and ACH estimates were discussed in Section 5.5. Figure 6-5 shows the computed average natural gas concentration

histories in a tenth percentile “small” garage (1,996 ft²) with a median ACH (0.54 air changes per hour) for the considered blowdown, discharge, and leak situations. In this case, a blowdown of a CNG vehicle full fuel tank would cause the average gas concentration in the garage to abruptly exceed the LFL. The maximum average gas concentration exceeds the LFL by almost a factor of eight, and nearly four hours lapse before the average gas concentration is less than the LFL. A blowdown from a CNG vehicle fuel tank filled to 900 psi would also produce an average gas concentration that exceeds the LFL for approximately 1.5 hours. Also, for these assumed conditions, the average gas concentration produced by a 0.67 scfm HRA discharge would eventually (after many hours) reach 3.7% (75% of the LFL). A 0.22-scfm leak would eventually result in an average gas concentration of 1.2% (25% of the LFL). Graphs of average gas concentrations for all five of the previously listed garage infiltration cases (i.e., ACH and garage volume combinations) are contained in Appendix E.

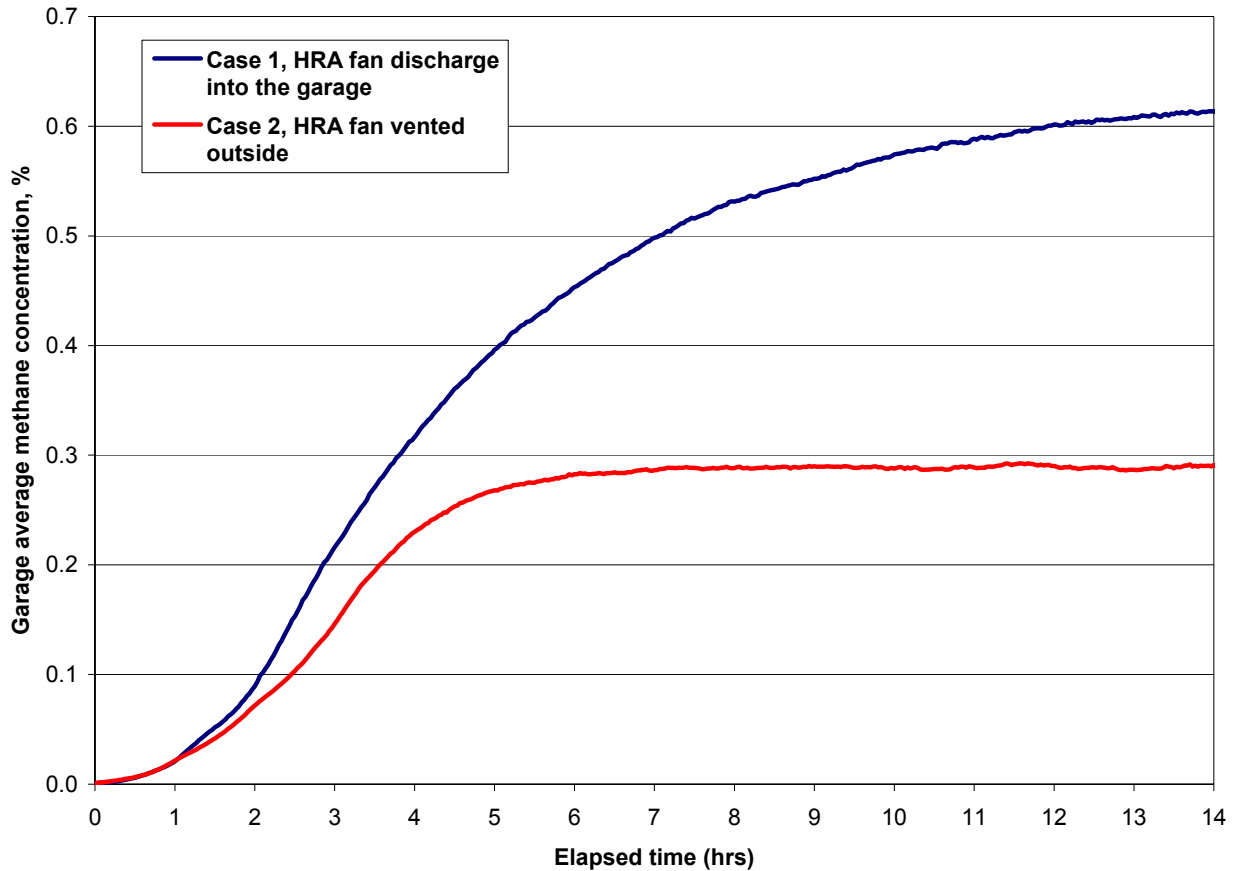
Figure 7-2. Garage volume average methane concentrations for Cases 1 and 2

Figure 7-2 shows the predicted average garage methane concentrations over time for the two gas leak cases evaluated. The steady state average concentration for Case 1, with the HRA cooling fan discharging into the garage interior, is 0.61%. Figure 7-2 shows that this is essentially reached at the end of the transient calculation period of 14 hours of continuous gas leak. The steady state garage average concentration for Case 2, with the HRA cooling fan discharged outside of the garage, is a reduced 0.29%. This average concentration is essentially reached after about 6 hours. The decreased steady state concentration for Case 2 is due to the increased infiltration caused by venting the HRA cooling air outside. By so doing, the garage ACH is increased to 1.0/hr.

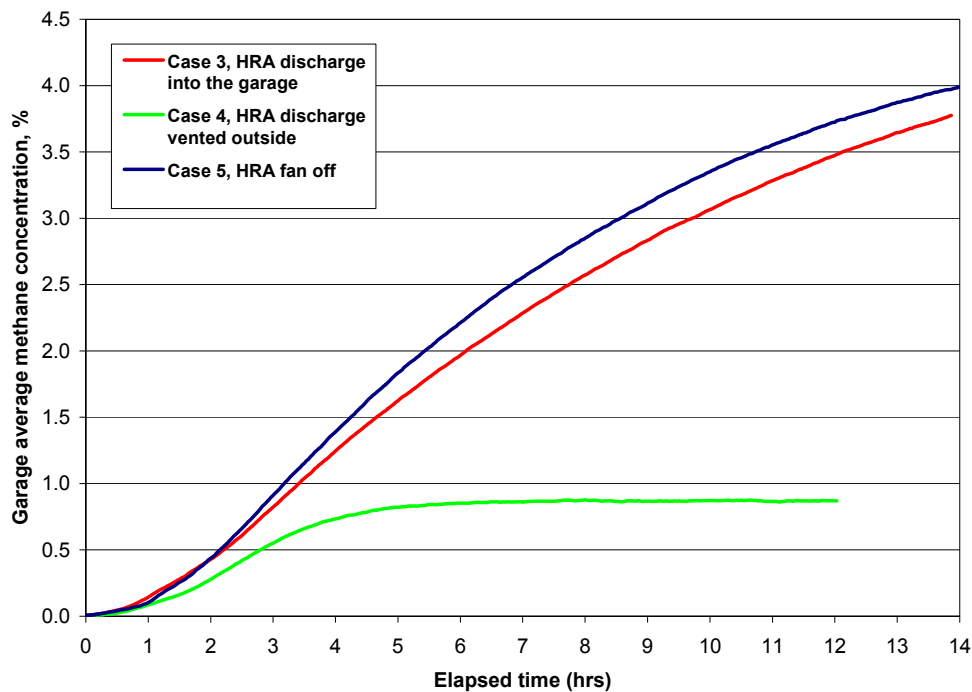
Figure 7-23 shows the predicted average garage methane concentrations over time for the three gas discharge cases evaluated. The steady state garage average concentration for a 0.67 scfm discharge into the garage with the HRA fan not running (the specification for Case 5) is 4.8%, the target average concentration for the steady state calculation performed to establish the garage door gap width and airflow restriction for Cases 3, 4, and 5. Figure 7-21 shows that this steady state concentration had not been reached after 14 hours of continuous discharge. This steady state average concentration is also not reached after 14 hours for Case 3, with the HRA cooling fan discharging into the garage interior. The steady state garage average concentration for Case 4, with the HRA cooling fan discharged outside of the garage is a reduced 0.87%. This average concentration is essentially reached after about 6 hours. The decreased steady state concentration for Case 4 is, again, due to the increased infiltration caused by venting the 80 cfm

Figure 7-23. Garage volume average methane concentrations for Cases 3, 4, and 5

of HRA cooling air outside. By so doing, the garage ACH is increased to 1.0/hr, the same as for the “leakier” garage assumed in Case 2. Figure 7-23 indicates that the Case 4 calculation was carried out for an elapsed time of 12 hours, instead of the 14 hours for the other cases. There was no need to extend the calculations to longer times for this case as steady state had been reached.

Figure 7-51 shows the isosurface of 5% methane concentration when steady state has been reached. This isosurface envelops much of the garage volume above the vehicles. Figure 7-52 is the corresponding isosurface of 4% methane concentration. The interpretation of Figure 7-52 is analogous to the interpretation of Figure 7-45. That is, methane concentrations of less than 4% are beneath the surface shown in the figure. Methane concentrations in the garage volume above the 4% isosurface are greater than 4%. Figure 7-52 suggests that most of the garage volume contains methane concentrations above 4% when steady state is reached. However, it bears emphasizing that, for the Case 5 scenario, reaching steady state will take significantly longer than 14 hours. Recall from the introductory paragraphs of Section 7.2, the steady state volume average methane concentration for the Case 5 scenario is 4.8%. At an elapsed time of 14 hours, the average garage methane concentration had only reached 4.0%, as shown in Figure 7-23, and its rate of increase is steadily decreasing.

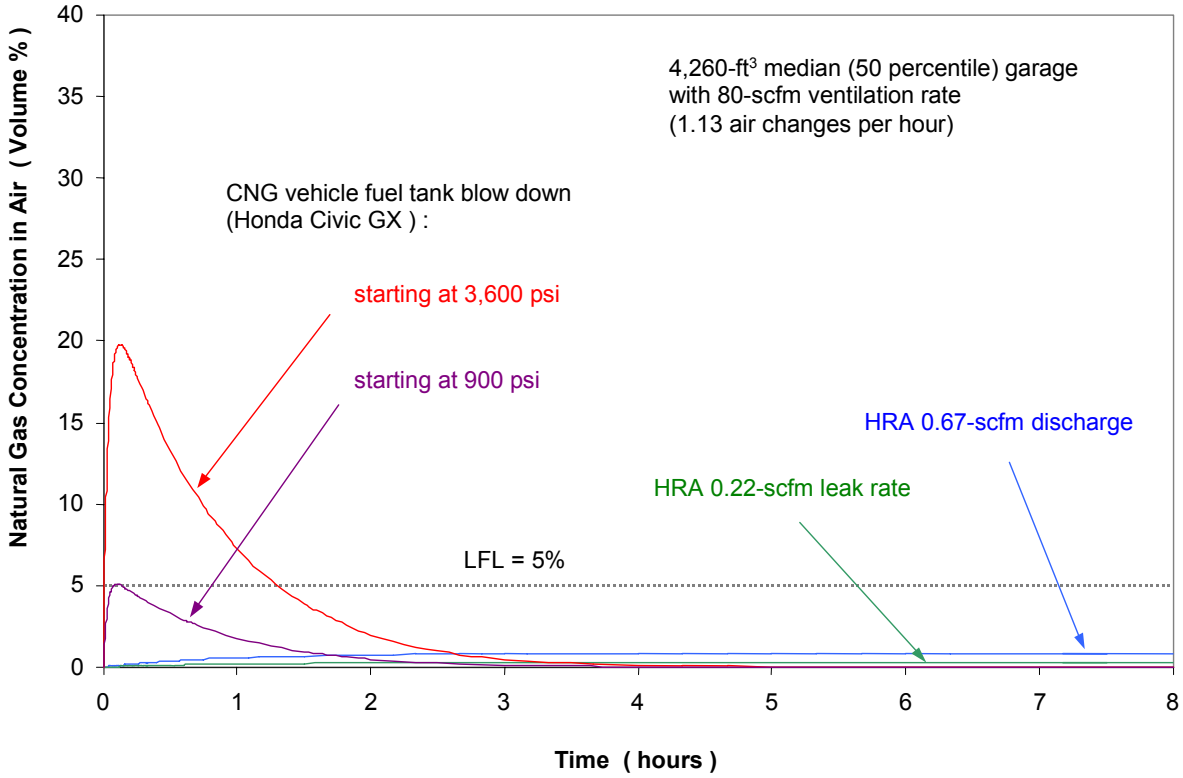
Figure E-4. Average gas concentrations with 80 scfm ventilation in a medium garage

Gas concentration reaches LFL at some location?	Yes: 0.001 No: 0.999	Note that a median-size garage with 80 scfm ventilation has ACH ~ 1.1. The average gas concentration will reach 90% of its asymptotic level of 0.28% (about 6% of the LFL) in about 2 hours. The gas will be well mixed at locations away from the leak, which is consistent with CFD results. It is highly unlikely that there will be any concentration gradients adequate to result in the build up of LFL regions anywhere in the garage.
	Delayed ignition where gas concentration >LFL?	Yes: 0.45 No: 0.55	The garage survey statistics indicate that approximately 90% of garages have ignition sources such as electric garage door openers or gas water heaters. As noted above, the possibility of LFL regions is quite remote, and such regions will probably be small if they do exist. Therefore, assume that there is a 50% chance that that such an LFL region would be collocated with an ignition source if one exists in the garage: $0.9 \times 0.5 = 0.45$
